OPERATING EXPERIENCE WEEKLY SUMMARY

Office of Nuclear and Facility Safety

September 4 - September 10, 1998

Summary 98-36

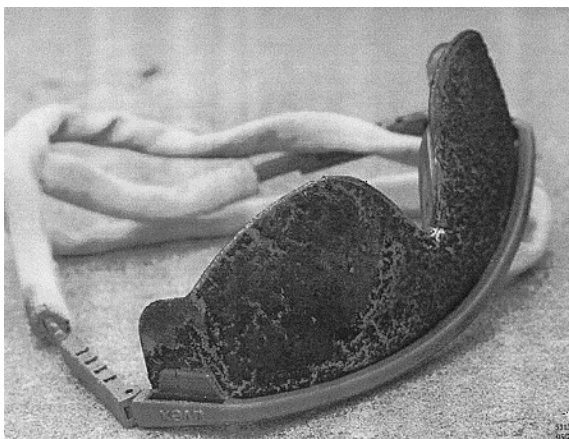
Figure 1-1. Electrician's Safety Glasses

Weekly Summary 98-21 reported that an electrician at the Kansas City Plant received second- and third-degree flash burns from an electrical arc blast while cleaning a 13.8-kV switch at an outdoor sub-station. The electrician was stunned by the arc blast and wandered in a nearby area until a maintenance team manager and two millwrights found him while investigating the cause of smoke coming from the area. A Patrol Sergeant tried to call 911, but was unable to reach an outside line, so a Patrol Lieutenant assumed responsibility and transported the electrician to a hospital using the site ambulance. During transport, the ambulance's brakes failed, no one could locate the external emergency ambulance lights, and accompanying personnel could not locate the first aid supplies. The electrician was later transferred to a hospital with a burn unit where he received skin grafts to his right arm and left hand. DOE assembled a Type B Accident Investigation Board to review this event. The Board completed the accident investigation report in July 1998. They identified the root cause of the event as lack of effective work integration and failure to responsibly implement the high-voltage work control process. The Board's report contains valuable lessons for other DOE facilities and is summarized in this article. Figure 1-

1 shows the severity of the burn marks on the electrician's safety glasses. (*Type B Accident Investigation Board Report on the May 24, 1998, Electrical Arc Blast at the Kansas City Plant, July 1998; and ORPS Report ALO-KC-AS-KCP-1998-0010*)

The Accident Investigation Board determined that the electrician used a paintbrush to clean the inside of a switchgear cabinet and did not know that the surrounding equipment was energized. Although they were unable to determine the exact event scenario, the Board concluded that an electrical fault was created either by debris falling onto energized equipment or by the electrician's shirt sleeve contacting energized equipment. Following is a summary of some of the Board's conclusions.

This event also demonstrates the importance of multiple engineered barriers to prevent hazardous events such as electrical shocks or discharges. Although human performance (supported by procedures, policies, memoranda, or standing orders) is a standard barrier to preventing electrical shocks and arcs, the probability of prevention can be increased by adding physical barriers such as lockouts and tagouts.

A good lockout/tagout program is an important element of an effective conduct of operations program. Lockout/tagout programs in DOE serve two functions. The first function, defined in both 29 CFR 1910, *Occupational Safety and Health Standards*, and DOE O 5480.19, *Conduct of Operations Requirements for DOE Facilities*, is to protect personnel from injury and protect equipment from damage. The second function is to provide overall control of equipment and system status. Lockout/tagouts are typically applied during maintenance activities; however, there are many cases when lockout/tagouts are needed for personnel safety. The standard states that an effective lockout/tagout program requires three elements. These elements are as follows: (1) all affected personnel must understand the program; (2) the program must be applied uniformly in every job; and (3) the program must be respected by every worker and supervisor.

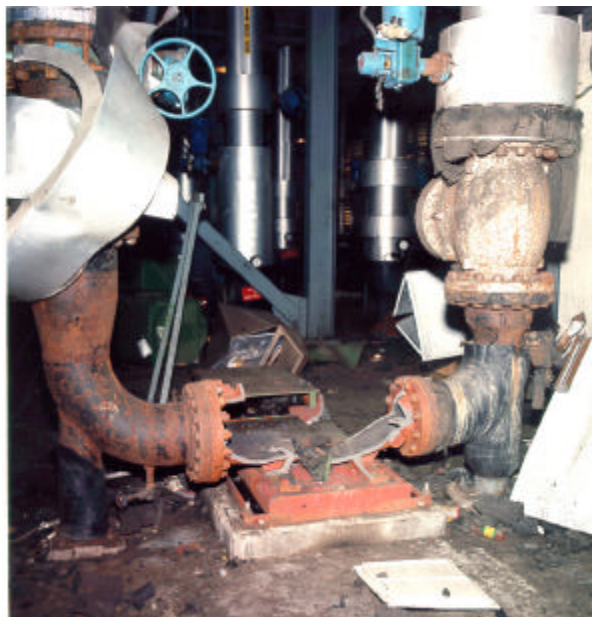
Figure 2-1. Pump Bedplate

Facility managers ordered a Type C investigation of this occurrence. Investigators determined that the direct cause of the failure was operating the pump with both the suction and discharge manual isolation valves closed. They determined that as much as 50 percent of motor horsepower could have been expended in raising the energy of pump contents, increasing internal pressure to as high as 3,000 psi over the 2-hour period the pump ran in the isolated condition. They also determined that pump contents flashed to steam when the casing ruptured, causing explosive destruction. The blast moved the pump motor 8 feet from its foundation, displaced an adjacent pump motor by 2 inches, and completely shattered the glass window of an operating enclosure.

Figure 2-1 shows the portion of the pump remaining on its bedplate. Figure 2-2 is a view of the general area surrounding the pump showing the extent of destruction and debris scattering. The window of the operating enclosure is at the top left of the photograph.

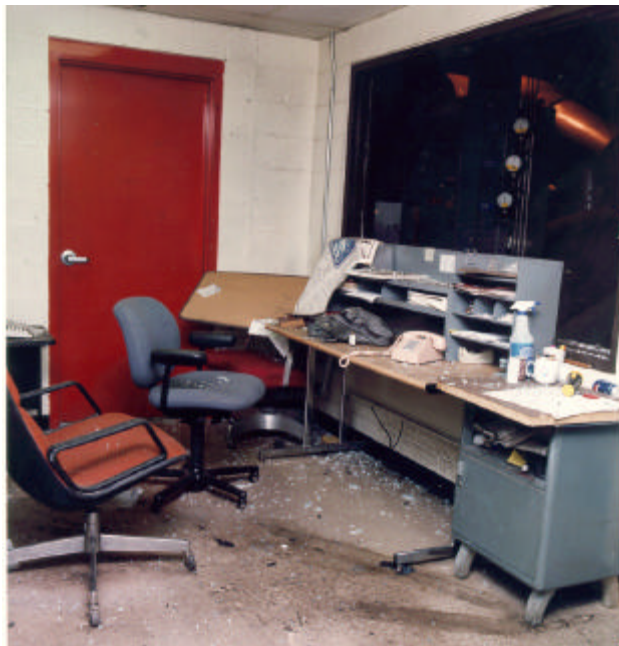
Figure 2-3. Operating Enclosure

Figure 2-3 shows an inside view of the operating enclosure.
